Volusia County

North Peninsula Beach and Dune Erosion

South Peninsula Beach and Dune Erosion

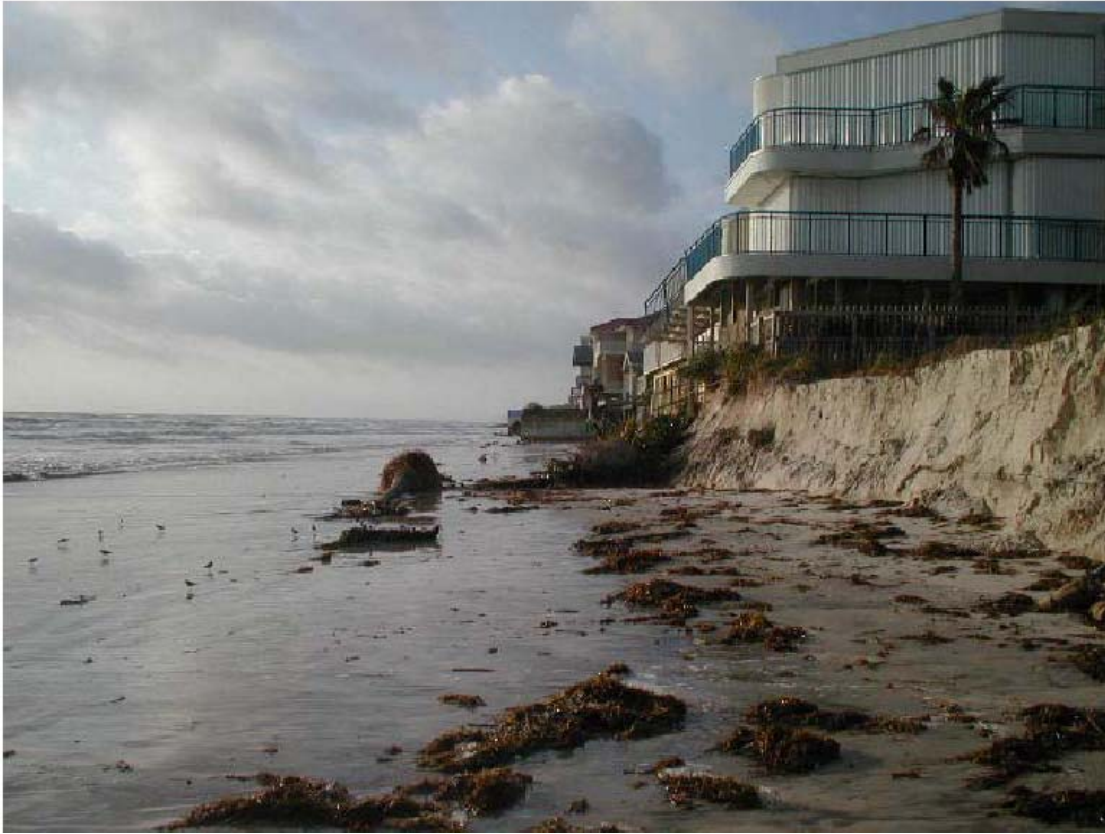
Photo 3: Major Beach and Dune Erosion, New Smyrna Beach

The Condition IV erosion impact of Hurricane Jeanne was particularly severe along New Smyrna Beach, where currently there is a complete loss of beach during high tide conditions (Photo 3). This loss of beach has led to the failure of a number of seawalls and created a pending storm threat to numerous upland dwelling structures. South of R193 throughout Bethune Beach and into the Cape Canaveral National Seashore, the Condition IV erosion that prevailed along New Smyrna Beach changed abruptly to accretion. Throughout Bethune Beach the beach berm grew to the point of covering the lower half of the coquina boulder revetments. This very unexpected result of two hurricanes' impact on an area that has historically been erosional is not readily explainable.

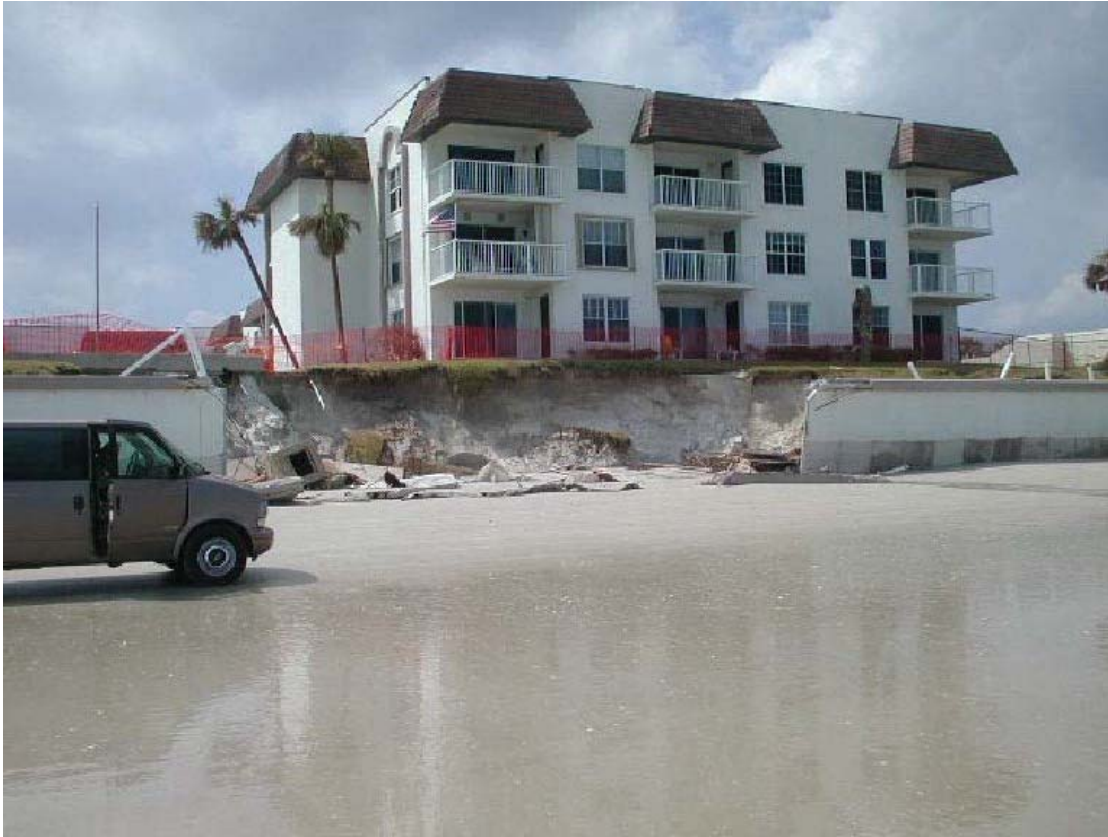
Photo 4: Seawall Damage, New Smyrna Beach

There are no beach restoration projects in Volusia County although the north peninsula extending northward from Ponce de Leon Inlet to Daytona Beach Shores received beach fill from inlet channel maintenance dredging in the past. Many vertical seawalls and bulkheads, some with rock toe scour protection exist along Ormond Beach, Daytona Beach, Daytona Beach Shores, Wilber-by-the-Sea, Town of Ponce Inlet, New Smyrna Beach, and Bethune Beach. During Frances no damage was sustained by these structures. Bethune Beach has a coquina boulder revetment along two segments which was designed and certified for a 100-year storm event. Frances likewise inflicted no damage to these revetments. In contrast, Jeanne damaged and destroyed some 19 vertical seawalls countywide having a total length of 5,430 feet (Photo 4).

Four of these damaged walls totaling 285 feet were located on the northern peninsula while 15 of these damaged walls totaling 5,145 feet were located in New Smyrna Beach. Once again there was no damage to the coquina boulder revetments in Bethune Beach. Unlike the scour caused by many vertical walls along the coast, the gradually sloping rock revetments appeared to have had no negative impact on the adjacent beach. In fact, sand even accreted on the revetments. Most of the concrete seawalls failed due to the same reasons including, lack of beach seaward of the walls, age of the structures, corrosion to the reinforcing steel, and lack of filter cloth behind the wall. A complete listing of the damaged and destroyed seawalls located by the Department's reference monuments is shown in Table 3.

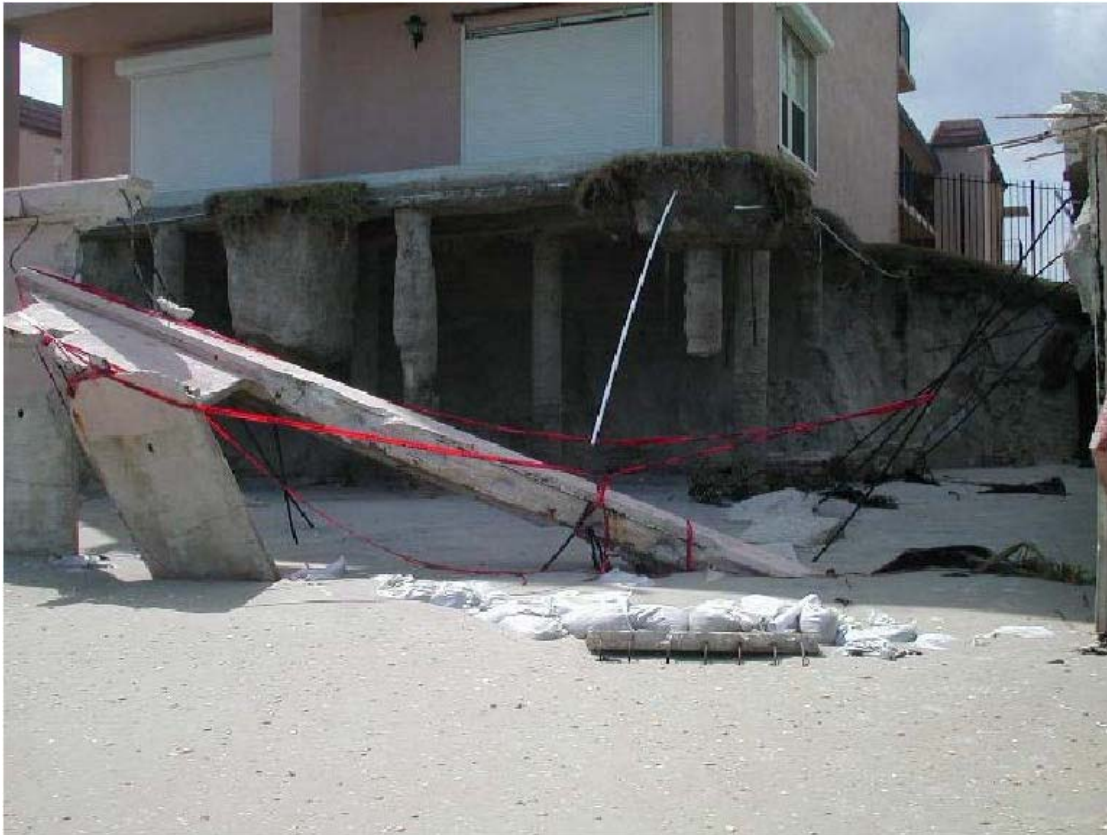
Photo 5: Building Undermined after Seawall Collapsed, New Smyrna Beach

South of Ponce de Leon Inlet along New Smyrna Beach and Bethune Beach, Hurricane Charley was observed to cause major roof damage to 11 single-family dwellings and two multifamily dwellings. Perhaps due to its closer proximity to the eye of Hurricane Frances, the south peninsula area sustained greater wind damage in the second storm including major roof damage to 18 single-family dwellings and nine multifamily dwelling structures. In addition, three single-family dwellings were destroyed and two other single-family dwellings and a multifamily dwelling had major side damage. Hurricane Jeanne also caused wind, wave, and undermining damage to major structures in New Smyrna Beach (Photo 5). Major damage was sustained by five single-family

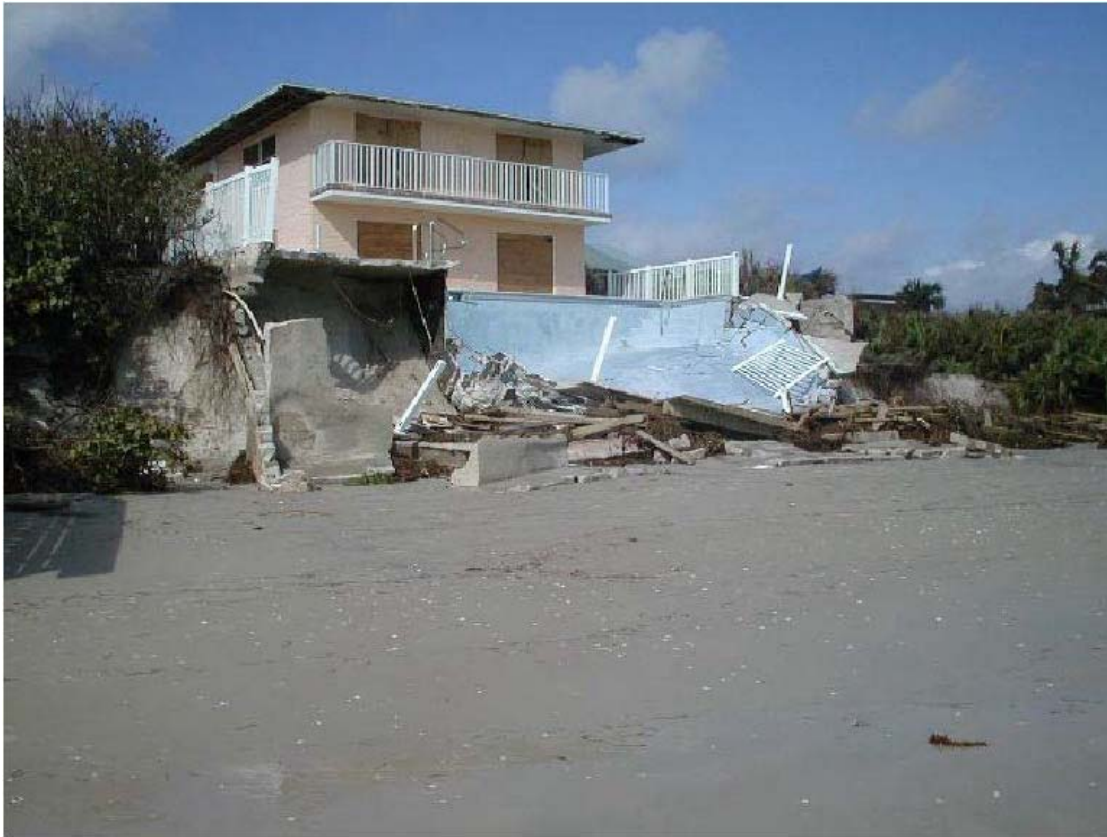
Photo 6: Pool Destroyed, New Smyrna Beach

dwellings, five multifamily dwellings, and a commercial building. Among the condemned buildings were a six-story, 62-unit condominium, two 33-unit condominiums, and a beach bar. In addition, a pool, a concrete pedestrian access ramp, and two vehicle access ramps were destroyed(Photo 6).
